# Rebuilding Wet Meadows Through Shared Stewardship

Posted by Aurora Cutler, Office of Sustainability and Climate, USDA Forest Service in [Climate](#), [Forestry](#), [Research and Science](#)

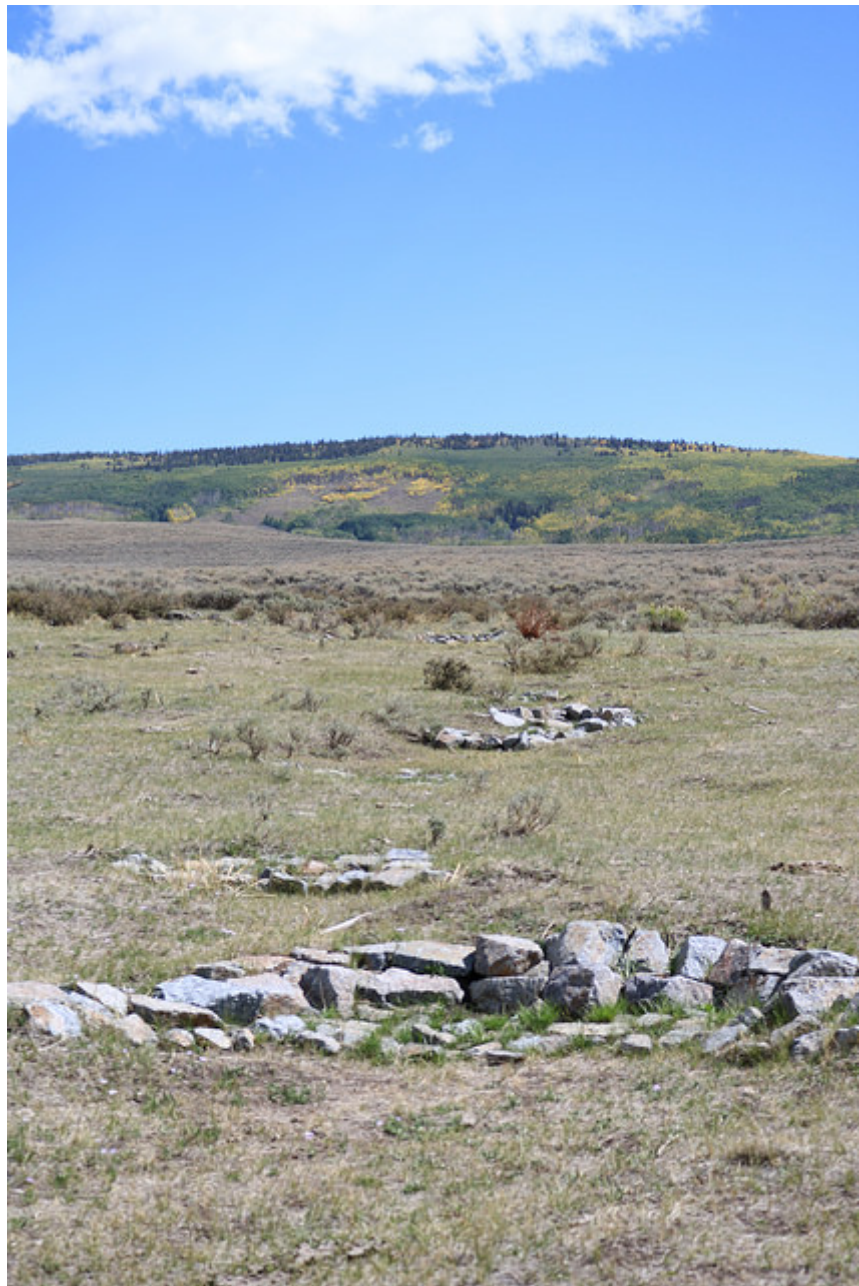
A rock dam above a meadow area on Flat Top Mountain on the Gunnison Ranger District. (Photo by Benjamin Soderquist, USDA Forest Service)

To adapt to these threats, the [Grand Mesa, Uncompahgre, and Gunnison National Forest](#) staff, [state and federal partners](#) , and local ranching families collaborated to slow and spread the flow of water across degraded sagebrush meadows. They built rock structures designed to raise the water table, reconnect stream channels to the floodplain, restore impacted soils, and increase wetland plant cover.

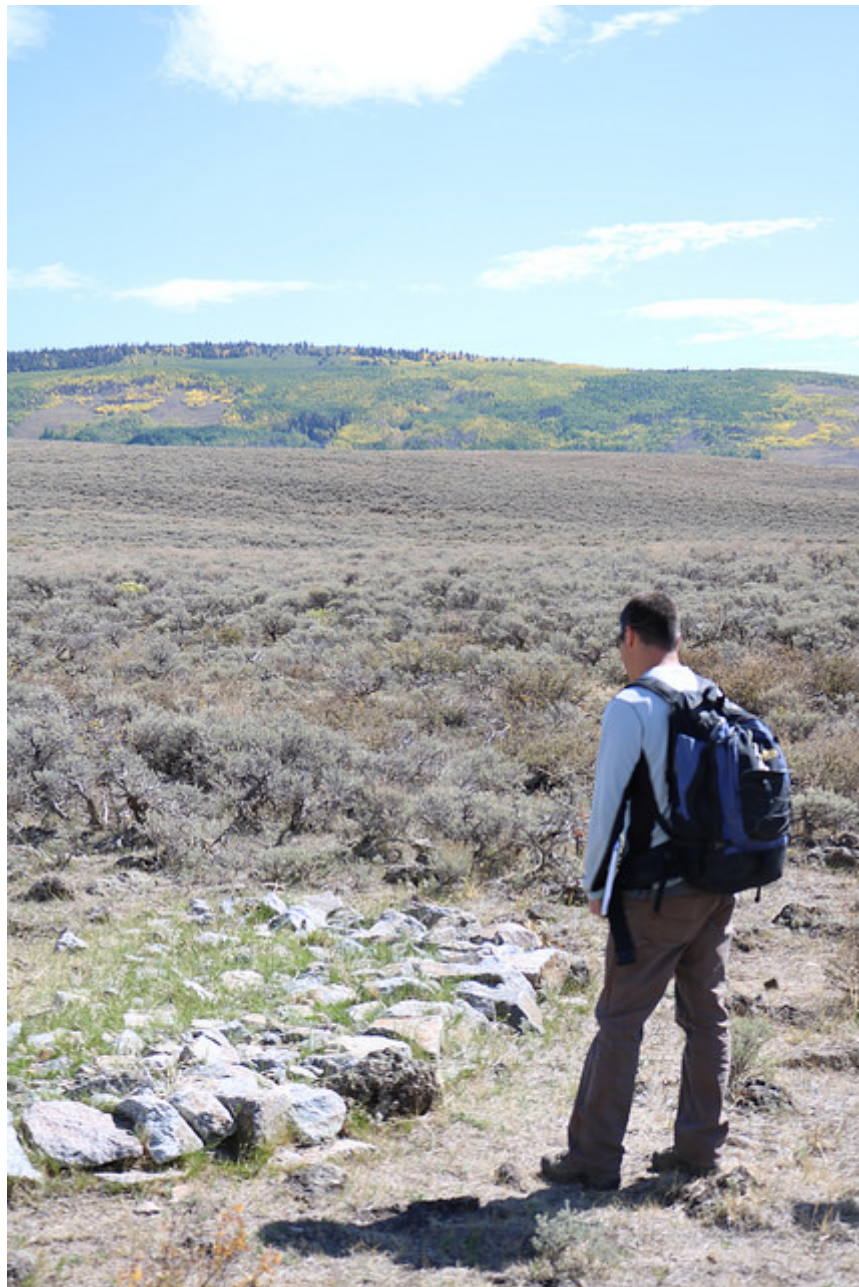
Forest Service Wildlife Biologist Matthew Vasquez stands near a rock

rundown that prevents soil erosion. (Photo by Benjamin Soderquist,  
USDA Forest Service)
